Contract #: 04-0120F4Cty: SF/ALA Rte: 80 PM: 13.2/13.9File #: 1.28**WELDING INSPECTION REPORT****Resident Engineer:** Casey, William**Address:** 333 Burma Road**City:** Oakland, CA 94607**Report No:** WIR-029495**Date Inspected:** 22-Apr-2013**Project Name:** SAS Superstructure**OSM Arrival Time:** 700**Prime Contractor:** American Bridge/Fluor Enterprises, a JV**OSM Departure Time:** 1730**Contractor:** American Bridge/Fluor Enterprises, a JV**Location:** Job Site**CWI Name:** As noted below**CWI Present:** Yes No**Inspected CWI report:** Yes No N/A**Rod Oven in Use:** Yes No N/A**Electrode to specification:** Yes No N/A**Weld Procedures Followed:** Yes No N/A**Qualified Welders:** Yes No N/A**Verified Joint Fit-up:** Yes No N/A**Approved Drawings:** Yes No N/A**Approved WPS:** Yes No N/A**Delayed / Cancelled:** Yes No N/A**Bridge No:** 34-0006**Component:** SAS OBG/Tower**Summary of Items Observed:**

WELDING INSPECTION REPORT

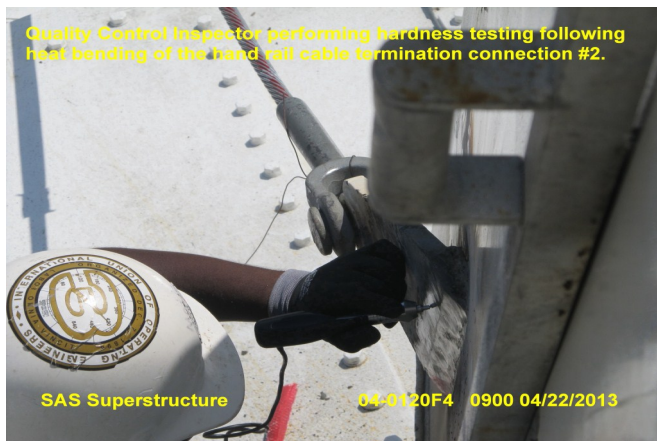
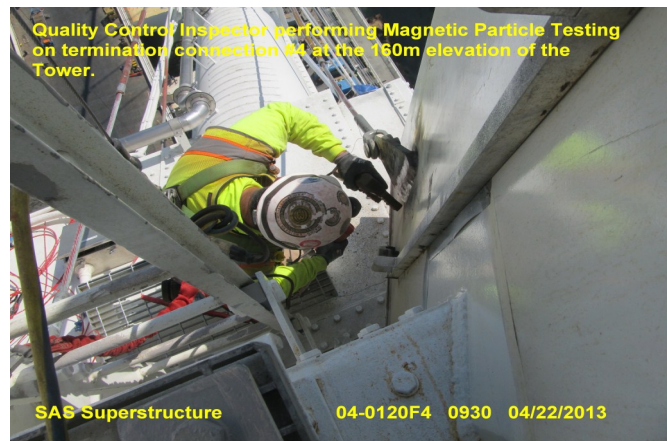
This QA Inspector randomly observed QC perform Magnetic Particle (MT) testing and Hardness Testing in accordance with RFI-003248R01 on the connection plates (lugs) that are attached to each of the Tower shafts of the Tower head for the attachment of the hand-ropes at the 160m elevation of the Tower. A total of four (4) readings were performed on lug's #2 (south main span), 3 (south side span) and 4 (north side span) and recorded. This QA Inspector noted that no rejectable indications were found at the time of MT testing.

This QA Inspector performed 100% Magnetic Particle (MT) testing along the length of, just above, and along the weld of the connection plates 2, 3 and 4 listed above. This QA Inspector performed MT testing utilizing the yoke method in conformance with ASTM E 709 and the standard of acceptance with D1.5 section 6.26.2.1. This QA Inspector noted that no rejectable indications were found at the time of testing. This QA Inspector generated a TL-6028 MT report on this date. The completed work at this location appeared to be in general conformance with the contract specifications.
